# 09

## Advanced Optical Metrology

### Corrosion

# 01 Effect of different amounts of graphene on metal friction and wear during the mixing process

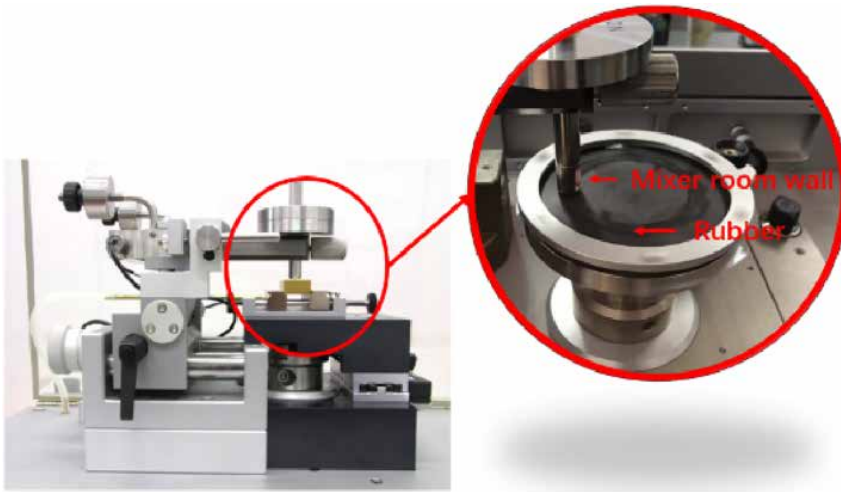
**Figure 2:** Configuration of the CSM wear test device

3. Friction and wear testing was carried out using a CSM. To this end, the experimental pressure, rotational speed, and the test time were set to 5 N, 70 rpm, and 120 min, respectively. In order to study the wear condition of the internal mixer end face, the same metal grinding head material and end face material were used in the experiment. To ensure complete silanization, the mixing temperature was kept at 145–155 °C (293–311 °F) for 1 min. The temperature of CSM was set to 150 °C (302 °F) to ensure the reliability of the experiment. CSM is shown in **Figure 3**.

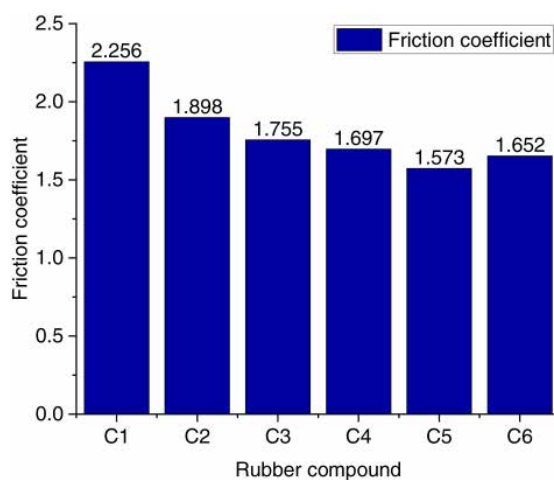
**Figure 3:** Average friction coefficient in different compounds

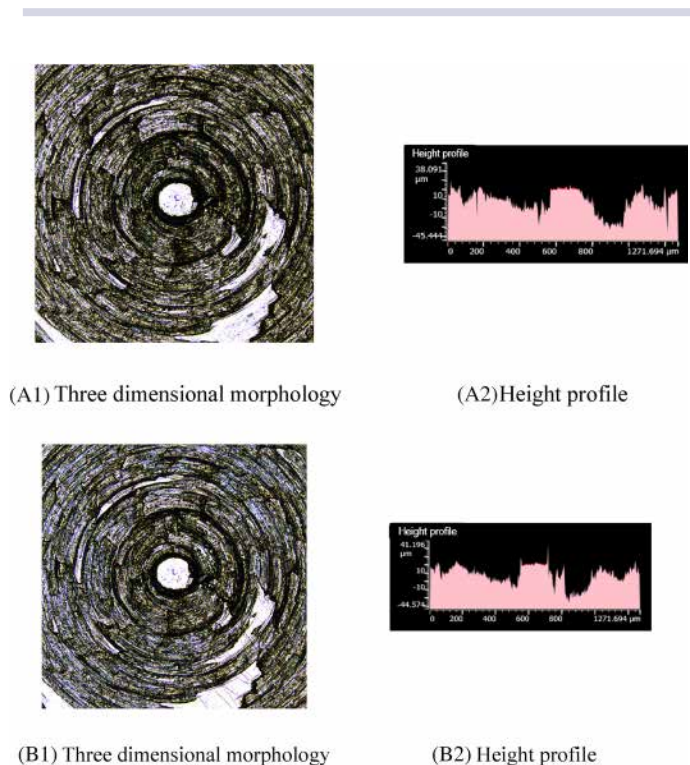
**Figure 4:** The surface morphology of the metal before and after the friction of the rubber compound without GE and TESPT (A1 and A2 are before friction; B1 and B2 are after friction). GE, graphene; TESPT, bis(3-triethoxysilylpropyl) tetrasulfide.

Comparing A1 and B1 in Figure 4, a large number of scratches appear on the metal surface after friction. Moreover, comparing A2 and B2, more pits appear on the height contour of the metal surface after friction, and the original height contour peaks mostly flatten. A large amount of silica aggregates in the rubber compound. Since silica has high hardness, the metal surface is worn so that many scratches appear on the metal surface after friction.

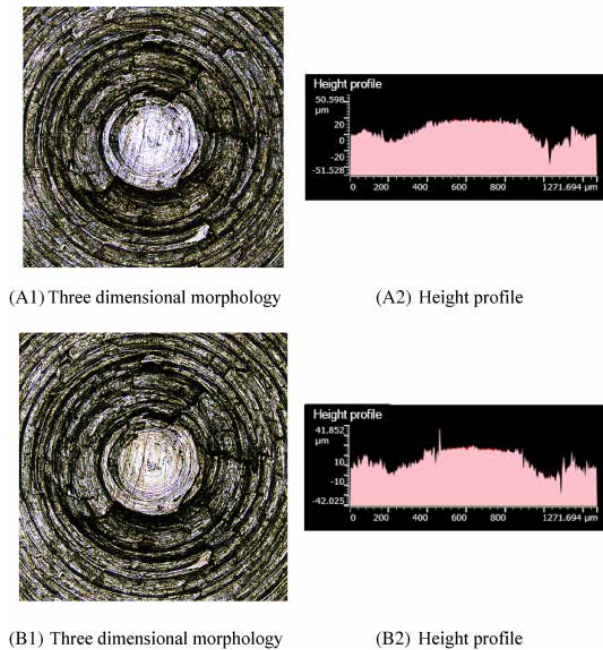
**Figure 9:** The surface morphology of the metal before and after friction of the rubber compound with 4 phr of GE (A1 and A2 are before friction; B1 and B2 are after friction).

**Figure 9** A1, B1 shows that there are more scratches on the metal surface after friction. **Figure 9** A2, B2 shows that after friction, part of the height contour peak of the metal surface flattens, pits appear in the height contour, and the overall height contour changes greatly. When 4 phr GE is added to the compound, a large amount of agglomeration between GE and TESPT is wrapped by GE, which hinders the silanization reaction, thereby producing a small amount of high-temperature ethanol vapor and a low amount of corrosive wear. Meanwhile, the hindrance of silica particles by GE sheets reduces, and a large number of silica aggregates appear. Consequently, the rubber compound with 4 phr GE has the largest abrasive wear on the metal.

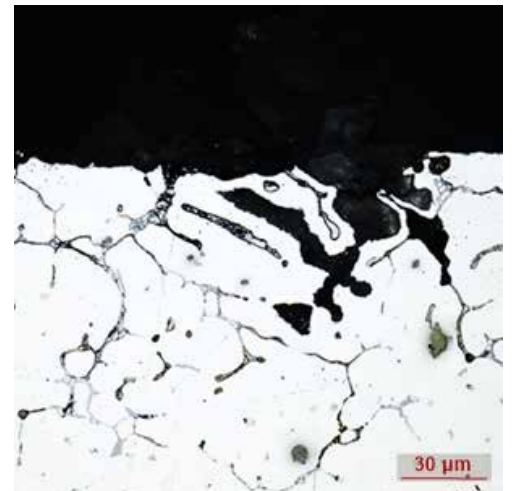
**Figure 4:** Microstructure of the sample after 480 h in a corrosive environment.

After longer exposure times, the corrosion attack spread in all directions. For clarity, **Figure 4** shows examples of pitting corrosion and the formation and spread of IC after only 480 hours of exposure in a corrosive environment. **Figure 4** shows the exclusion of phases along grain boundaries and interdendritic porosity at grain boundaries. In this case, the corrosion products penetrate to a depth of  $75\ \mu\text{m}$  from the sample surface. The detail documents the violation of the cohesion of the material.
